Step By Step: Engine Trapdoor Insulation Restoration

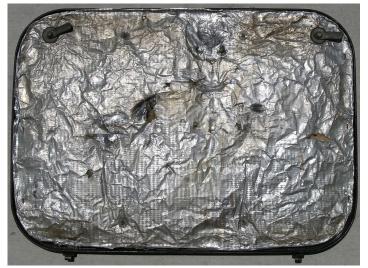
Over the years the underside insulation of the engine trapdoor will deteriorate, get ripped & torn, and need restoration back to its original condition. This restoration cost is less than \$25 and can be done in 2-3 hours.

Original engine trapdoor insulation (above) Stripped engine trapdoor (below)

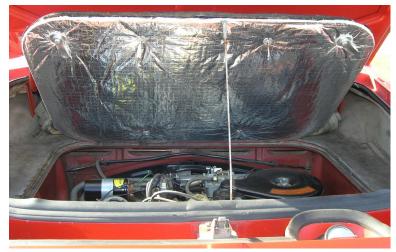
On early T34s (1962-63) the original diamond-pattern insulation had the foil glued onto the outer edges of the insulation. On later T34s (1964-69) the insulation was tucked inside the outer edge (see bottom pic). This diamond pattern is hard to reproduce.

For the edges (depending on your year T34), either pull the foil over the outer edges of the trapdoor & glue into place (1962-63), or tuck the foil inside the outer edges (1964-69). Install the latches & rubber latch buffers. Finally, replace the restored trapdoor in your T34 and test the function of the latches.
