STEP BY STEP: Front Hood Drain Tubes

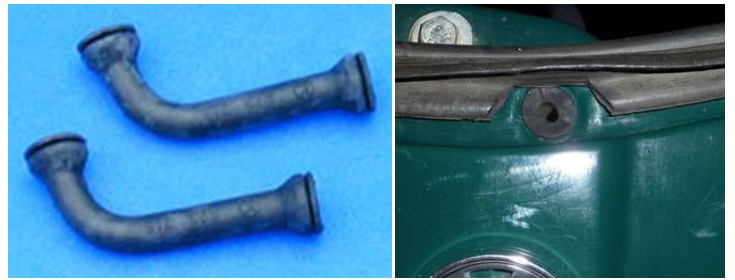
Repro front drain L-shaped tubes & tube installed in drain hole

FUNCTION: The front hood drain hole has a small L-shaped black plastic tube that clips into the hole. The bottom end of this tube is pushed into a long black rubber tube that is 49cm (19.3") with a 1.0cm inner diameter & 1.4cm outer diameter. This tube is held in place by two thumb-tabs welded into the inner nose. On early T34s with the dual inner horns this long tube is pushed into a hole cut in the inner dual horn boot so the water will drain out onto the ground. On late T34s the 2nd L-tube is pushed into the bottom opening of the long tube and then into the horn cover plate hole so it's flush with the opening, draining out onto the ground.

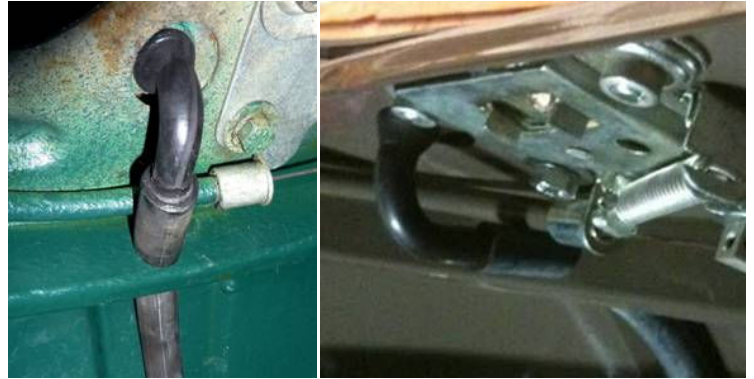
L-shaped tube from underneath hood

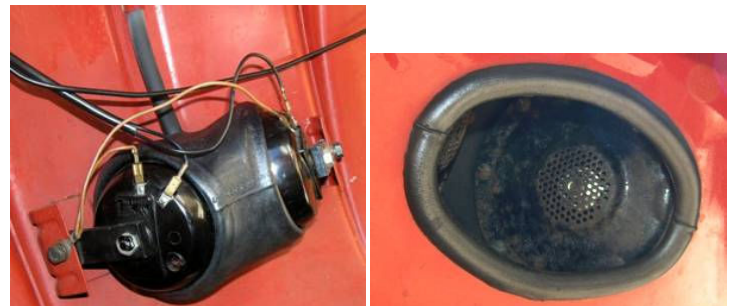
Early style: inner dual horns & seal

VARIATIONS: There are two different variations for T34s: the early style with the dual horns inside the spare tire area and the late style with the dual horns mounted under the front bumper. The early style has a large rubber boot that covers the dual horns and seals the horn hole opening from water getting in. The late style has a metal plate covering the horn hole with a small hole at the top and a black seal around the edges.

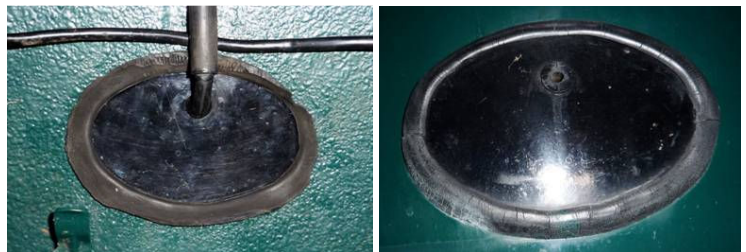
Late style: metal cover plate & seal with second L-tube
