Step By Step: Lug Nut & Brake Drum Restoration

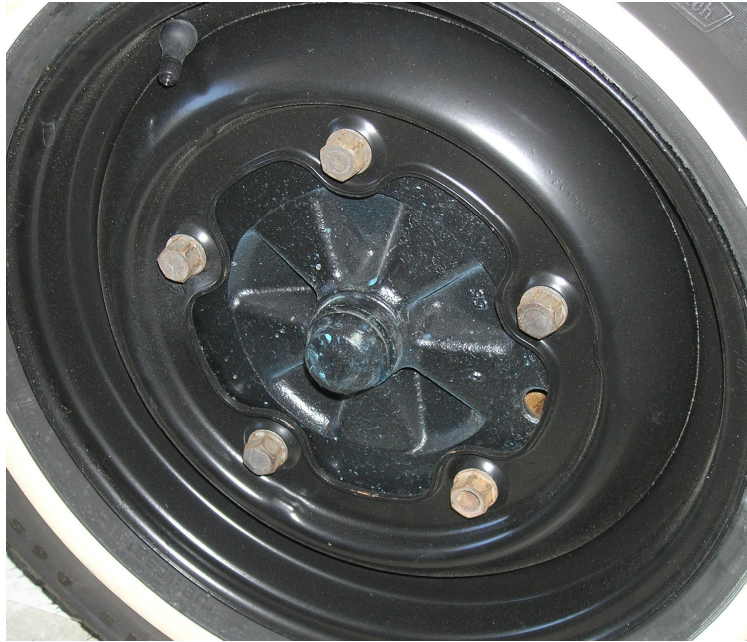
After you've bought new tires & powdercoated the rims and install them onto the T34 you notice the drums & lug nuts are not detailed like they should be. Detailing is an easy process.

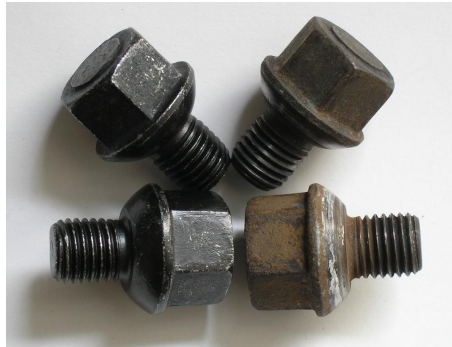
Early model 5-lug T34s (1962-65) have M12x1.5 lug nuts with 20 per car (below). 1966-69 T34s changed to 4-lug and have M14x1.5 lug nuts with 16 per car.

zinc process transforms the lug nuts, sandblasting off the rust, applying a zinc coating then a black chromate coating (see comparison above). The black-zinc coating will not add a layer of paint that may crumble & loosen over time like paint.

First thing is to remove the lug nuts. The original T34 lug nuts were black but over the years have turned a nasty combination of rust, grease, & grime. Package them up and send them off to a plating shop that specializes in Black-Zinc coatings. The black-

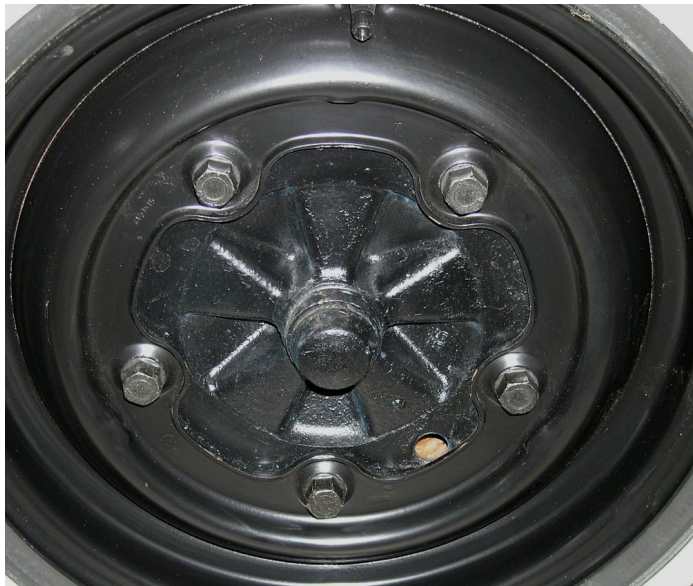
Next turn your attention to the brake drums. The outside surface is also nasty with grease, dirt, and old paint. Begin by removing the drum and degreasing it. Then use a wire wheel attached to a drill to clean off all the remaining rust & dirt. Finally use 160-grit sandpaper to clean up the minor blemishes. Fifteen minutes of cleaning and they'll be ready for paint. Mask-off the inner hole & lug nut holes with masking tape and use an Exacto knife to trim the tape close to each hole (right). Spray several coats of high-temp glossy black paint (below right) and let dry overnight. Remove the tape and install the brake drum.

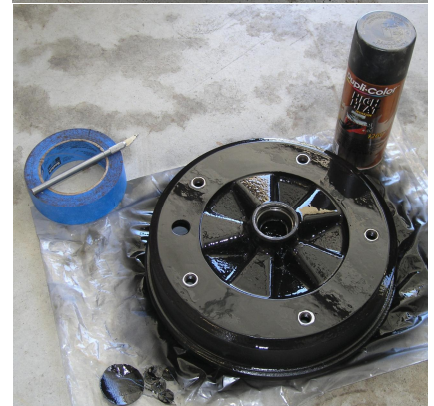
With freshly painted drums and black-zinc lug nuts, your T34 will look perfectly detailed to match the restored rims & new tires.

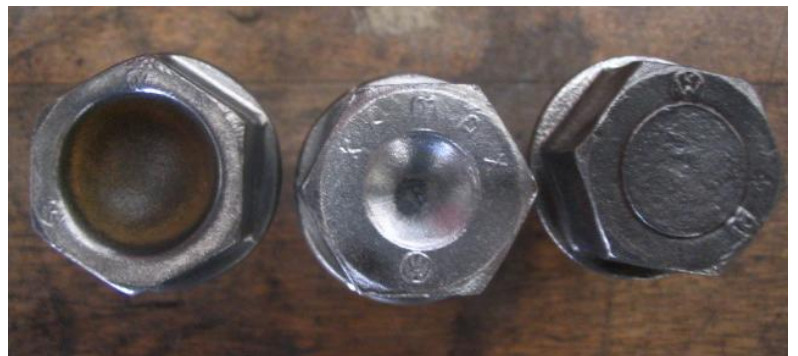
FYI: we found there are three different styles of original early T3 lug nuts. One is extremely dished, one is slightly dished with the letters KAMAX, and the third is flat. All three styles have tiny round VW logos printed on the top. Although it's impossible to tell from owners manual photos which one is authentic, it seems that the flat ones are most common on early T3s. The dished styles may have been replacement nuts or simply from a different vendor.
