Wartungsdienst - Typ 3

Maintenance Service - Type 3
Service d'entretien - Type 3
Servicio de Mantenimiento - Tipo 3

Maintenance Service for Volkswagen 1500

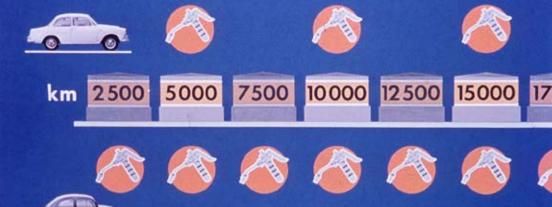
18/2 - The proven 3000 mile maintenance interval is also applicable to the Type 3 - which is the internal designation of the Volkswagen 1500. If we compare the VW 1500's lubrication chart with that of the Type 1 -Volkswagen 1200, we notice that the lubrication service too is only carried out at the same 3000 mile intervals the further developed front axle of the Type 3 with its ball joints which need little servicing does not require the in-between lubrication.

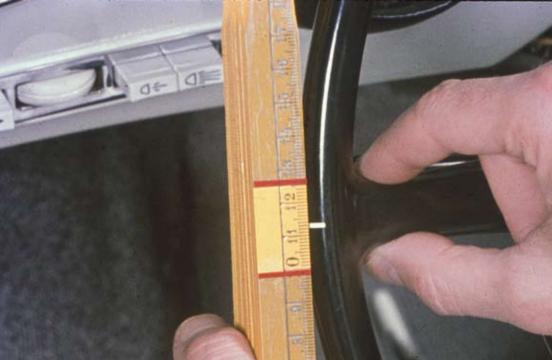
18/4 – Before raising the vehicle, check the steering play. Turn the wheels to the straight-ahead position and move the steering wheel at the outer end of the spoke lightly to and fro as shown here. If the steering is correctly adjusted and the tie rods and steering coupling are in perfect condition it should only be possible to turn the steering wheel 1" until resistance is felt in both directions.

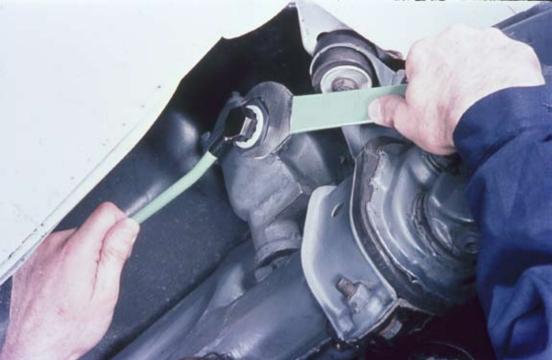
18/6 – The presence of steering worm axial play can be ascertained by moving the steering coupling to and fro with the wheels locked.

If there is play, loosen the lock nut and tighten the adjusting screw until no play is detectable. Hold adjusting screw and tighten the lock nut as shown here.

The wrenches shown here are VW 277 and 278 a. When turning the steering worm there should not be any unusually tight positions noticeable. If there are, the adjusting screw is too tight.

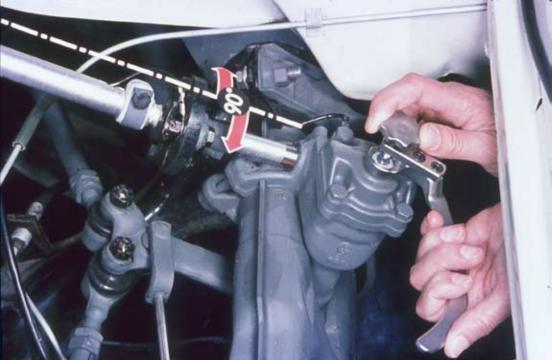
18/7 - It is best to use the special combination wrench shown here when adjusting the steering roller. We turn the steering wheel 90° to one side, loosen the roller shaft adjusting screw lock nut - the box wrench is shown in position here – and loosen the adjusting screw approximately one turn with a screwdriver. Now we tighten the adjusting screw until the roller contacts the steering worm, we hold the adjusting screw and tighten the lock nut. If we have done this correctly we then check the steering play at 90° to the other side and, if necessary, make corrections in the same manner. It is important to note that the adjustment must always be checked on both sides at a lock of 90°.

If the range of play cannot be adjusted to the prescribed dimension, the steering gear must be removed and the axial play of the steering roller checked.

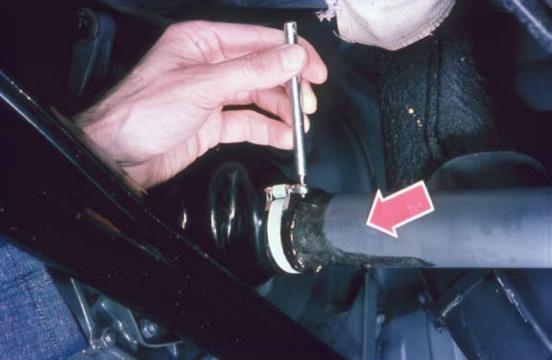
18/8 – If the vehicle is raised we first of all check the engine and rear axle for leaks during the 300 mile maintenance service. If we were to do this later on, there is the danger that the causes of possible leaks may have been eliminated by the operations already carried out. If small leaks cannot be immediately eliminated by tightening up bolts and clips,

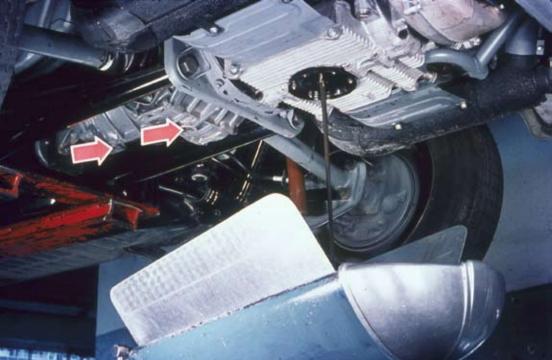
18/10 - After checking for oil leaks we drain the engine oil immediately, and during the 300 mile maintenance service - then every 15,000 miles - the transmission oil. On the one hand impurities will drain off better with the warm thin oil and on the other hand the engine will cool down quicker – a fact which has a major affect on the valve clearance and ignition adjustments which are carried out later on.

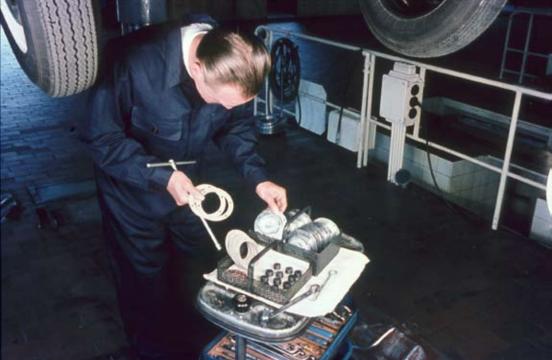
18/11 - Of course we do not forget to clean the oil strainer each time and the magnetic oil drain plugs at the prescribed intervals. New strainer gaskets and a new gasket under the engine drain plug are necessary for ensuring freedom from leaks for the next 3,000 miles. Time can be saved if, as shown here, cleaned strainers and drain plugs are kept ready for installation. Every minute saved is of importance during maintenance services.

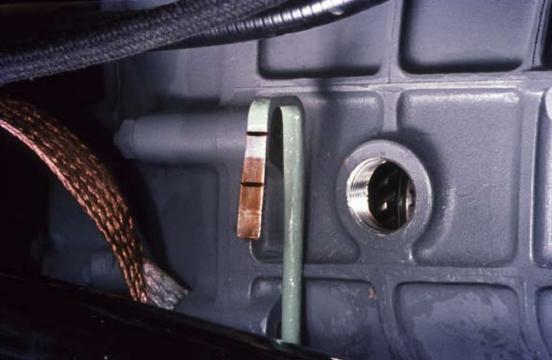
18/12 – To be on the safe side the oil level in the transmission should be checked after every oil change with the help of the oil dipstick for Type 1 VW 679 local manufacture. The difference between the upper and lower mark is exactly 1.75 lmp. pints and 2.1 US pints.

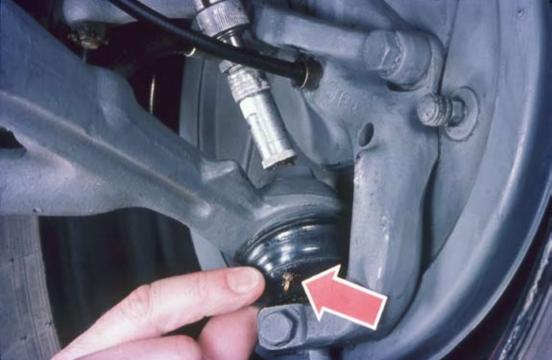
18/13 – All the 8 grease nipples of the Type 3 are located on the front axle. Whereas grease is inserted into the torsion arm bearings until it emerges at the edge of the lubrication points, the ball joints are lubricated in a different manner.

These joints are sealed with dust seals which can only hold a limited amount of grease. The grease will not emerge as in the case of the nipples. A few shots of grease are sufficient to replenish the grease. Squeeze the seals to see if they are full. In any event stop lubricating when the grease begins to emerge at the small relief holes.

Damaged dust seals must always be replaced. This also applies to the dust seals on the maintenance-free tie rods. Entries should be made immediately in the card "Defects noted during Maintenance" if defects of this kind are noticed.

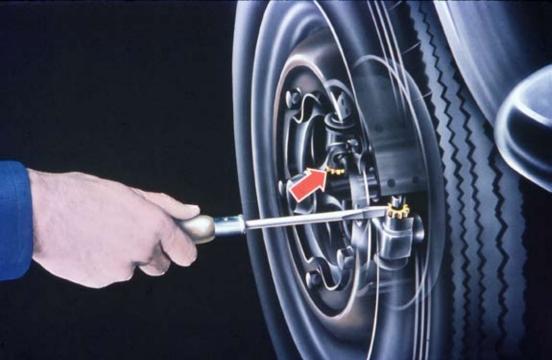
18/15 – In the Type 3 the brake shoes are also adjusted by turning the adjusting nuts with a screwdriver. The two wheel cylinders of the front twin leading shoe brakes are offset by 180° as in the VW Commercial. After adjustment the brake pedal should be depressed heavily a few times so as to avoid any danger arising should the brakes shoes not have centered properly.

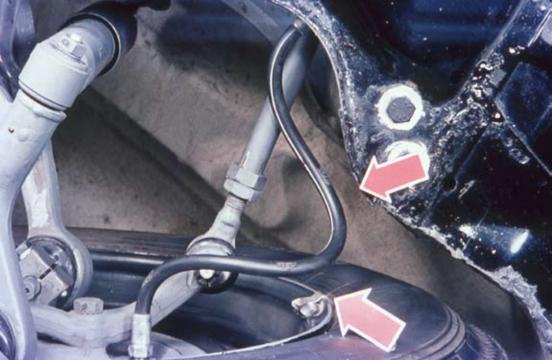
18/17 – A damaged brake line or a worn brake hose, for example, impair the safety of the hydraulic brakes and endanger the lives of the vehicle occupants and other road users. When carrying out a visual check we should be very strict and also carry out this operation very carefully during maintenance services.

Here you see how a twisted and thus incorrectly installed brake hose is nearly caught between rim and frame when the wheels are locked. Under certain driving conditions it might begin to rub. (To illustrate the twist of the hose we have painted the edge of the hose white.)

Take note also of the hoses when making the visual check and bear in mind that contrary to Type 1 the front brake hoses of Type 3 have to be installed without twist and must sag.

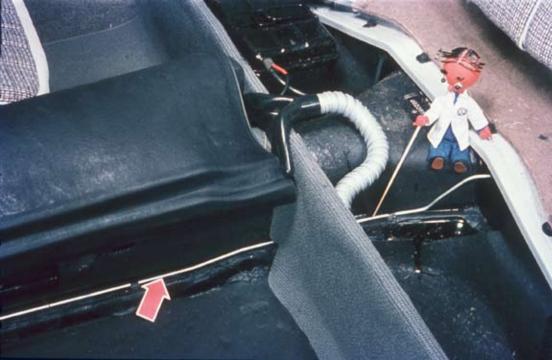
18/18 – Do not forget to check the brake line running inside the vehicle: particularly in older vehicles corrosion may set in if the line has been exposed to dampness for a long while.

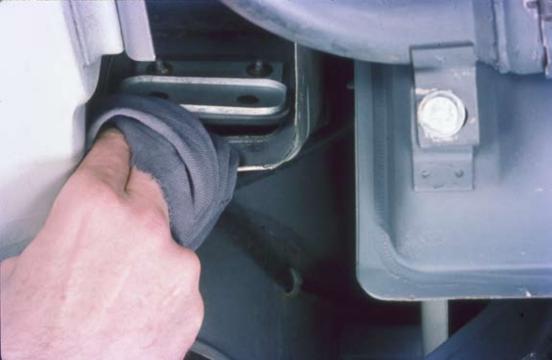
18/20 - The water drain flaps are kept closed by vacuum whilst driving and prevent the fan from drawing in air from secondary sources. These flaps act as valves to a certain extent and must have sufficient free movement and seal properly. They are, however, not subject to much wear and are located in a protected position.

In general all we have to do is to keep the contact surfaces and the seal clean.

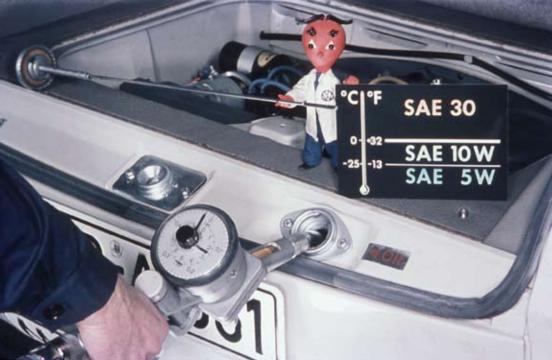
18/21 – When the hoist is lowered half way we fill in new oil. This helps to cool the engine and, as we know from Type 1, exact valve clearance and timing settings cannot be carried out on a hot engine. If multi-grade oil is not used we must pay attention to the instructions concerning single grade oils which differ on Type 3 and Type 1.

You should make a habit of checking the oil level after each oil change.

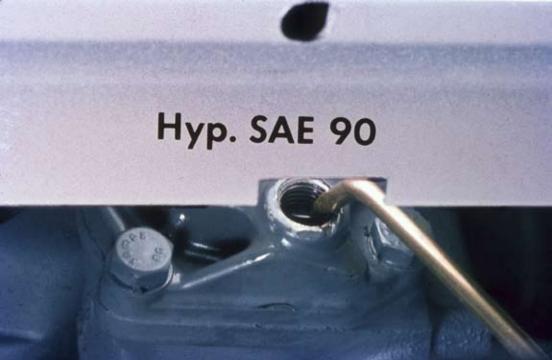
18/22 - Type 3 has the same roller steering as introduced on Type 1 from August 1961. The Iubrication and maintenance instructions for the steering are the same for both models. In Type 3 we must remove the spare wheel well if we want to check the oil level in the steering gear. The oil level should be up to the lower edge of the filler hole. Only Hypoid oil SAE 90 must be used for topping up the same oil as specified for the transmission.

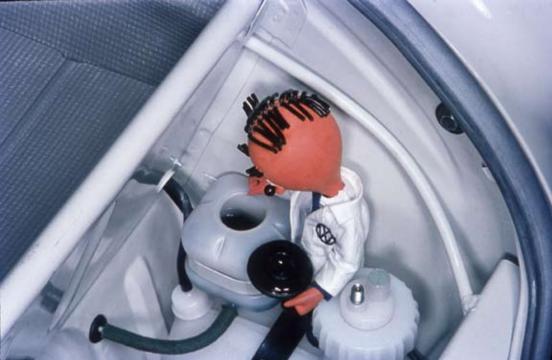
18/23 – We must always be suspicious if brake fluid losses occur between maintenance services. In such cases we must check the brake system very carefully and examine the lines and connections with the brake pedal depressed.

If the leak cannot be eliminated immediately during the maintenance service we must on no account omit to make an entry in the card "Defects noted during Maintenance".

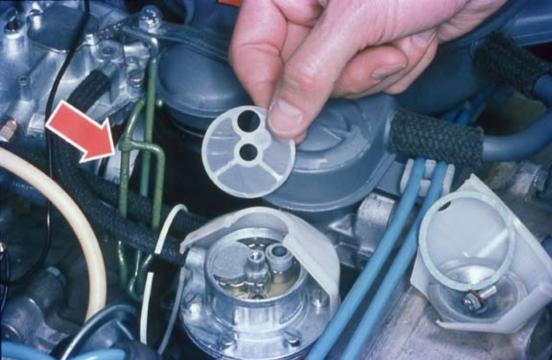
18/24 — The presence of a fuel pump filter saves the time spent in cleaning the carburetor.

The arrow shows the hose clamp with which we seal off the feed hose before removing the cover. The filter is cleaned with benzine. Hardened gaskets should always be replaced. Make sure that the cover seats properly by moving it slightly to and fro so that the pump does not draw in air.

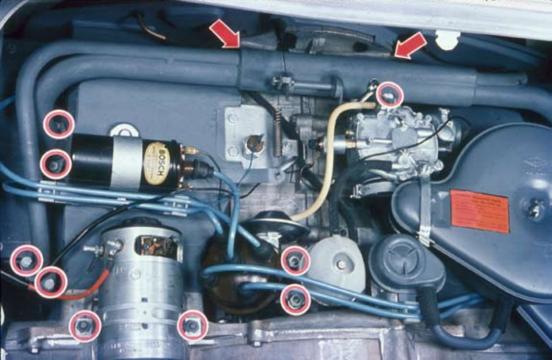
18/25 — This picture shows the connections on the engine which require particular attention during the 300 miles maintenance service.

The connections shown in rings are the nuts and bolts on the intake manifold, pre-heating pipe, fuel pump, carburetor and generator mounting strap. The bolts of the upper engine mounting shown here by the two arrows have to be checked for tightness.

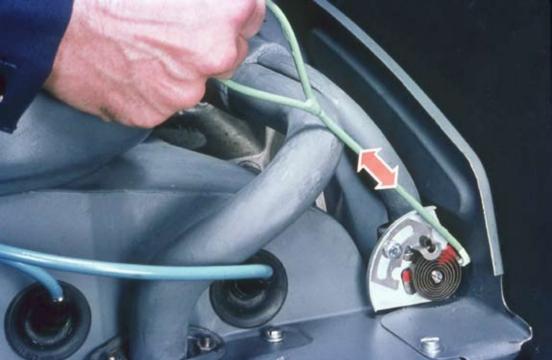
18/26 – In August 1962 the pre-heating pipe was provided with a valve which heats the intake manifold via a bimetal spring.

During the maintenance service we check the valve throttle for free movement by pulling up the operating lever behind the bimetal spring shown in red against the spring pressure. When released, the lever must return to its original position immediately. If it is stiff, it can usually be freed off by pulling and releasing the lever a few times. If this is not successful, the valve must be removed after the maintenance service has been completed, freed off or replaced.

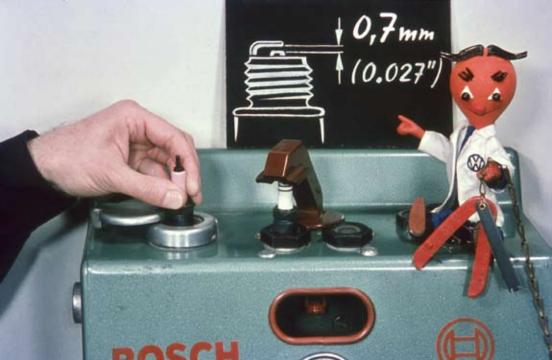
18/27 - Not much time can be spent when cleaning the spark plugs. This operation can be carried out successfully by a sand blaster in a few seconds. Please note, however, that depending on the amount of deposits, the sand blaster should only be operated for about 5 to 10 seconds on no account for a longer period. If this period is exceeded not only will the deposits be removed but also the electrodes and insulator will be affected.

If necessary the plug gap is re-set to 28 thou.

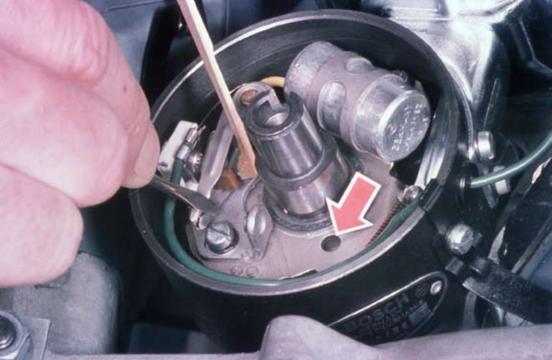
18/28 - Care should be exercised when lubricated the distributor to ensure that oil or grease is only applied

where it is really required.

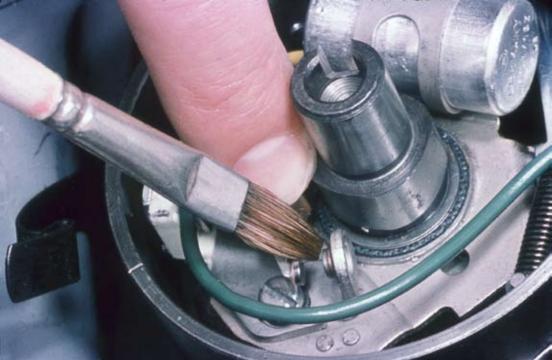
18/29 – The breaker points should always be washed in benzine during maintenance services. The distributor cap should also be cleaned on the inside and outside and the breaker housing blown out with compressed air. On the other hand, the contacts should not be removed and filed each time.

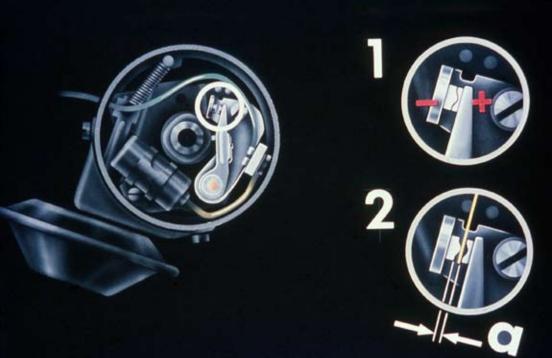
18/30 – During the course of operation material is transferred from one contact to the other. If this is only slight the function of the contacts will not be impaired.

Picture 1 shows how a hole has formed on the breaker arm with the corresponding build-up on the fixed contact.

Picture 2 illustrates how then contacts are often adjusted incorrectly in such cases.

If these contacts are measured with a feeler gauge and the build-up is not taken into consideration, the measuring error shown here will occur: The actual contact gap is the height of the build-up plus the thickness of the 16 thou feeler gauge. "a" denotes the incorrect gap. These mistakes can be avoided if we insert the feeler gauge at the edge only.

Oxydized contacts or those with excessive build-up can be removed and cleaned up but in most cases this takes too long. The best and most economical way is to replace the contacts.

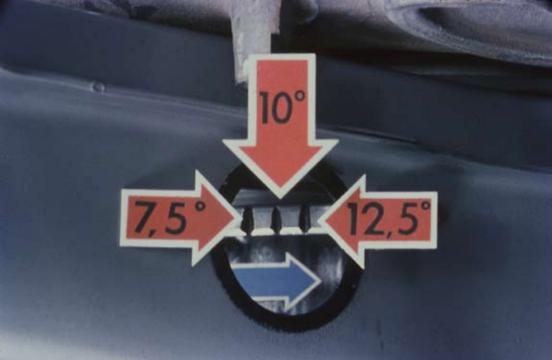
18/31 - The crankshaft pulley now has 3 timing marks. The left mark signifies 7.5° the center one 10° and the righthand one 12.5° before T.D.C. The blue arrow denotes the direction of turning. In general we are only interested in the central mark as most of the 1.5 litre engines are set to 10° T.D.C. The 12.5° marking, only valid for approximately 20,000 vehicles between chassis numbers 65 567 and 84 751 which had a modified carburetor adjustment. We must, however, bear these chassis numbers in mind. If a engine tends to pink when using fuels with insufficent anti-knock properties, the timing can be retarded 2.5° each time.

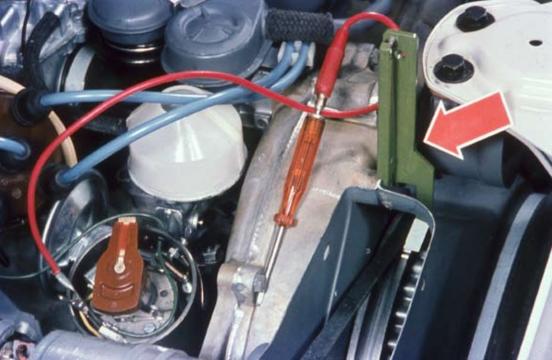
18/32 - The engine must always be sufficiently cold before the ignition can be checked or set. The oil temperature in the crankcase must not exceed 50 °C (122 °F). When checking and adjusting the ignition timing we use a 6 volt test lamp and the adjustment gauge VW 660 which is mounted on the adjustment surface of the fan housing. The point of the gauge and the center of the timing mark on the crankshaft pulley must be in line. The engine must only be turned in a clockwise direction to take up the play in the distributor drive gear.

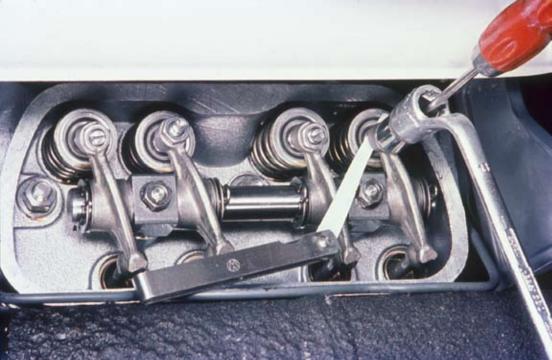
18/33 - The valve clearance is also affected by the heat of the engine: the clearance is reduced when the engine becomes warm. This is why the valve clearance should only be checked or set when the engine is cold or fairly warm. As opposed to the 34 bhp engine the clearance is: for intake and exhaust valves 12 thou at a maximum oil temperature of 50 °C (122 °F). Since a normal 13 mm box wrench is not suitable we use a lengthened socket wrench which consists of a box wrench and a 13 mm socket wrench insert which can be made by every workshop.

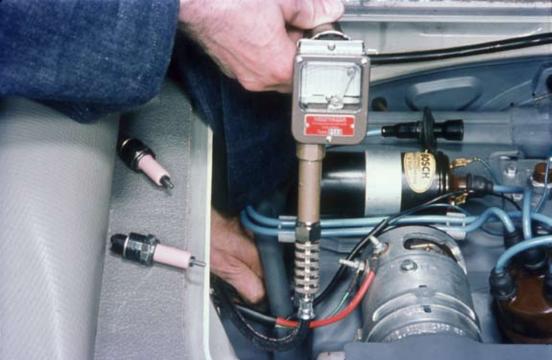
18/34 – By checking the compression we gain knowledge on the condition of the engine. In particular we can ascertain whether the compression in one cylinder has fallen. To obtain comparative values with earlier tests it is necessary to check under the same conditions i. e. engine temperature, starting motor revolutions and testing devices should be the same.

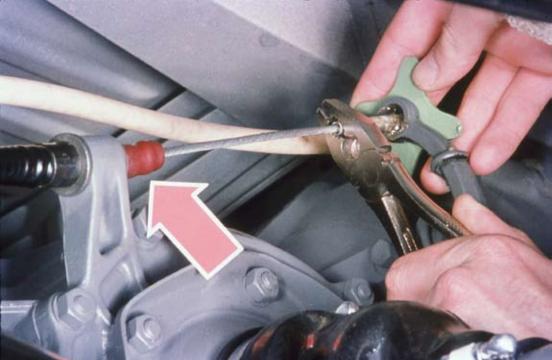
18/35 – The locally manufactured starshaped adjusting wrench is suitable for all Volkswagen models. This will also facilitate the clutch adjustment operations on Type 3.

If we lubricate the ball socket in the threaded piece generously the adjusting nut in the clutch lever will have sufficient free movement and we can save ourselves the trouble of having to free off the adjusting thread during the next maintenance service. The arrow shows the sealing sleeve at the end of the cable guide. Here too we must make sure that it is properly seated.

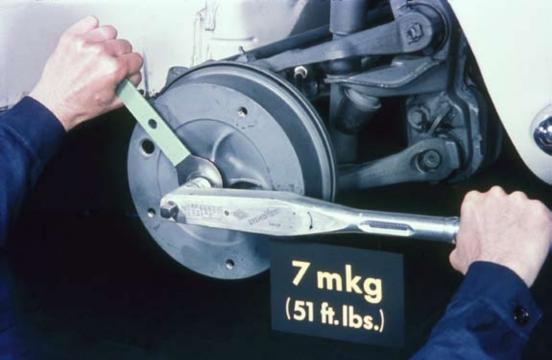
18/36 — The front wheel bearing play is checked at the 300 mile maintenance service. If it is necessary to adjust the bearings we use a torque wrench.

First of all the inner bearing nut is tightened to 21 ft. lbs. This seats the bearings properly. Now slacken the nut until the thrust washer can just be moved with a screwdriver, hold the nut in this position and tighten the lock nut to 50 ft. lbs. Always use a new lock plate. This operation is shown here. The bearings are correctly adjusted if we can just move the thrust washer and the wheels moves freely in both directions without axial play.

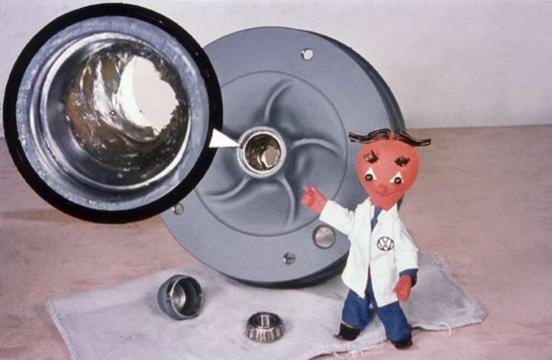
18/37 — Before lubricating the front wheel bearings at 30,000 miles with grease as specified in the Maintenance Chart, the bearings and inner hubs are washed out carefully and the bearings checked for wear. The prescribed heat-resistant multi-purpose grease is packed between the cages and the rollers and the space between bearing seats is also filled with grease.

Why is it wrong to fill the complete hub with grease? Only a very thin layer of grease lubricates the roller bearings: superfluous grease must have space to expand into the hub.

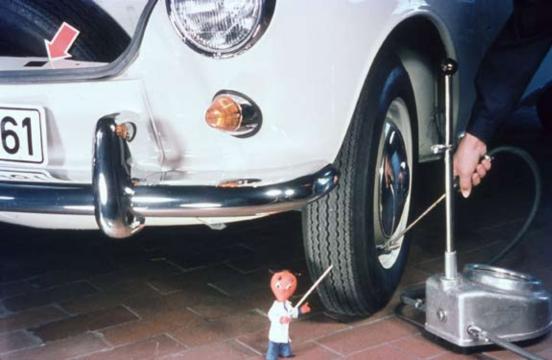
18/38 – The pressures of the low section tires on Type 3 must be strictly adhered to so that full advantage can be taken of the excellent driving characteristics of the car. It is absolutely necessary that the tire pressures are correct when checking the camber and toe-in.

Unless stated otherwise by the customer, the correct tire pressures for the Sedan and Coupé for fast motorway driving is 17 lbs./sq. in. at the front and 24 lbs./sq. in. at the back. These values apply also to the two Variant models under half-load conditions. The red arrow points to the location of the tire pressures for the vehicle in question. Only on the Coupé are there pressures shown on the inside of the glove compartment lid.

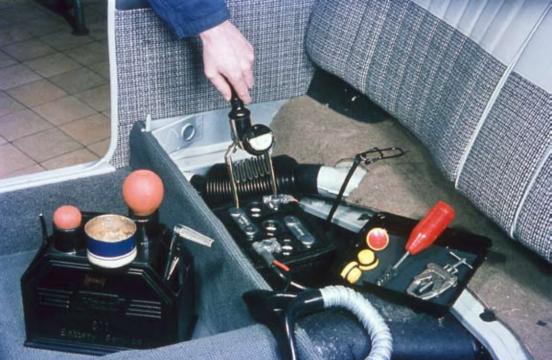
18/39 - If all the auxiliary tools are readily to hand it only takes a few minutes to see to the battery. The acid level should be topped up to the correct mark. A damp oily film on the battery - nearly always a sign of excessive acid - should always be carefully removed. This layer facilitates tracking and causes the battery to discharge. We use a cell tester to check whether the battery is sufficiently charged and that the cells are in order.

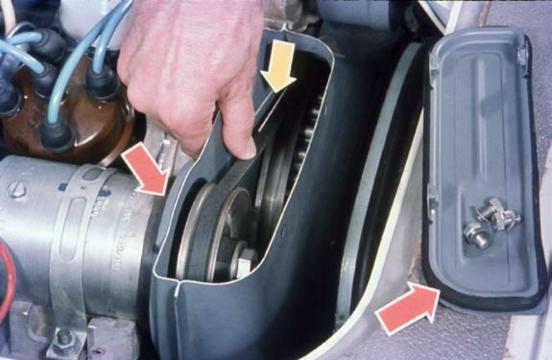
18/40 — In Type 3 only the generator is driven by the V-belt. This however does not relieve us of the obligation of checking it for correct tension. When pressed firmly with the thumb it should yield approximately .6". The tension is altered in the usual way by removing or inserting spacer washers.

We also check whether both pulley halves run true and do not foul the housing. The yellow arrow shows the correct distance between V-belt and housing. The clearance should be .16" at least.

The red arrows point to the rubber boot on the housing and the housing cover gasket. Both seals must be undamaged and be correctly seated if the generator is to be cooled efficiently.

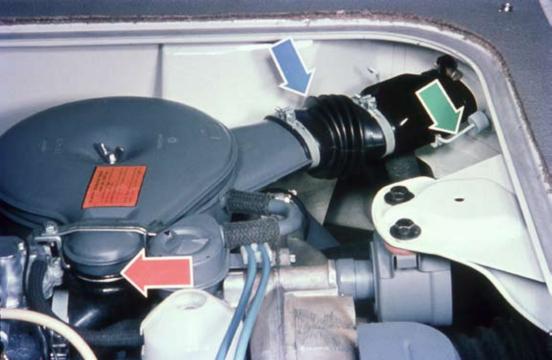
18/41 – After cleaning oil bath cleaner it is filled with 0.44 lmp. pints or 0.53 U.S. pints of SAE 20 engine oil.

The red arrow points to the connection between air cleaner and carburetor. We must make sure that the elbow is a proper fit on the air cleaner before we tighten the retainer. The green arrow points to the preheater flap. This flap is checked for free movement as well as the seating of the pre-heating control box on the intake duct. The blue arrow illustrates the boot which must be in perfect condition and must seal efficiently.

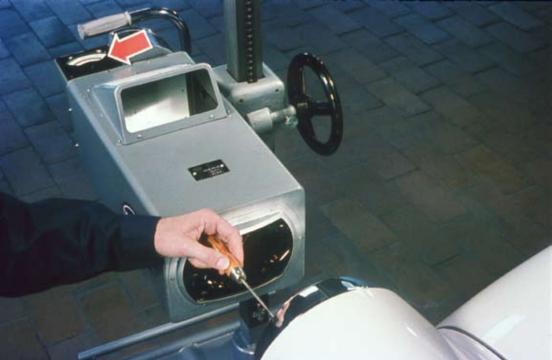
18/42 – These are official regulations concerning the adjustment and brightness of headlamps. Both headlamps must be equally bright. The arrow points to the light meter which is incorporated in the aiming device. The brightness of the headlamps can be read from this device. If the minimum values are not reached we must make an entry in the card "Defects noted during Maintenance".

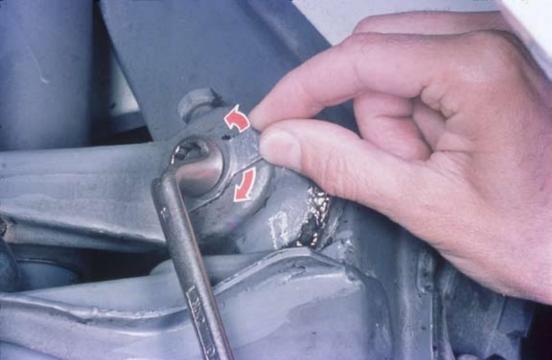
18/44 - If the thrust rings show signs of wear the torsion arms must be adjusted by the adjusting screw situated at the right-hand torsion arm: Loosen the clamping bolt which is secured by a lock nut on the top of the torsion arm and after bending up the lock plate tighten the adjusting screw - shown here with the box wrench in situ. This will center the torsion arms. The adjusting screw is now removed and a new lock plate fitted. We now move the lock plate to and fro in the direction of the red arrows and tighten the adjusting screw until the lock plate can just no longer be moved by hand. This operation is shown in the picture. Now tighten the clamping bolt and secure with the lock nut. We then tighten the

adjusting screw slightly — check the axial play as shown in the previous picture — and secure the screw with the lock plate.

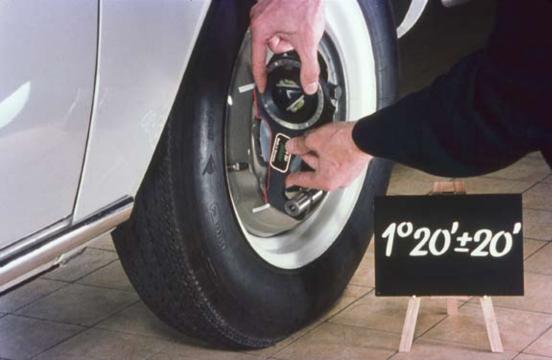
18/45 - The vehicle must be level if the camber and toe-in are to be measured correctly. The vehicle must also be unladen and the front wheels in the straight-ahead position. Two measurements are taken with the protractor VW 261 to avoid incorrect readings. Here you see how we position the protractor on the wheel disc. We mark the location with a piece of chalk and ascertain the camber value. We now push the car back or forward half a wheel turn and take measurements at the same location again. We divide the sum of both readings by two to arrive at the mean value which must not be above or below the specified value of 1°20′ ± 20′.

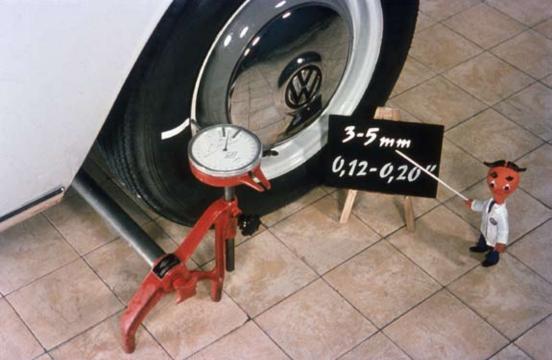
18/46 – We then check the toe-in. Adequate readings can be obtained if we use an alignment gauge which is provided with a dial indicator. The toe-in of Type 3 when unladen should be between .12" and .2".

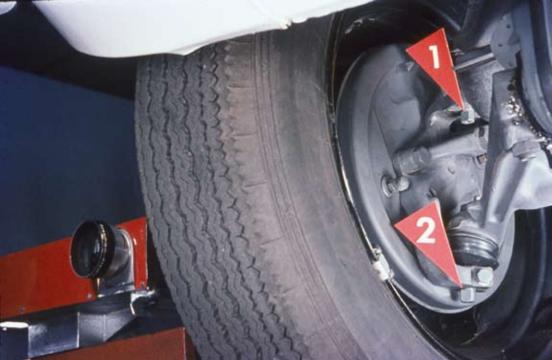
18/47 - If the camber and toe-in values deviate from the prescribed readings the vehicle will have to be driven to a special measuring bay. This is the only way of ensuring that we can carry out the adjustments under the vehicle with its wheels on the ground as specified. First of all re-set the camber by means of the eccentric pin in the upper ball joint - arrow 1. Only if this adjustment is not sufficent do we effect an adjustment at the lower ball joint (arrow 2).

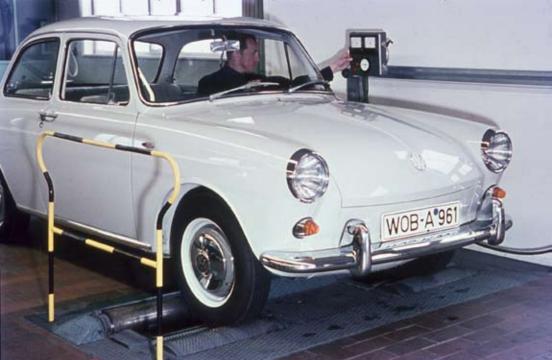
18/49 – If a stationary test stand is not available, the vehicle will have to be road-tested after the maintenance service to check the vehicle thoroughly and to see if the adjustments have been carried out satisfactorily.

The use of a brake test stand does away with the necessity of the less reliable brake test and the element of danger. Here we see the car on the roller test stand which makes it possible to get a clear picture of the braking force of each individual wheel at a certain pedal pressure.
